TECHNICAL REPORT 04

DESCALING ELECTRONIC EQUIPMENT

ELECTRONIC DESCALING EQUIPMENT

Regarding the installation of a ScaleWatcher electronic descaling device in a leach water aqueduct between Mine and Head Pool SX, we can inform the following:

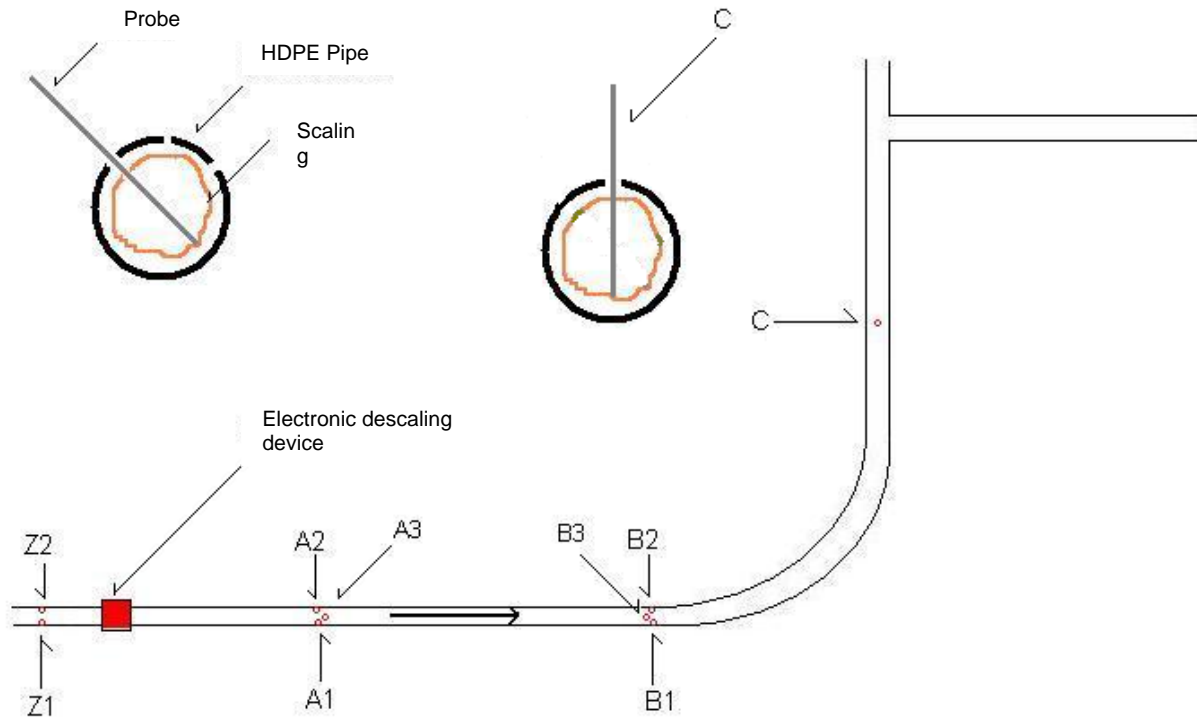
Diagram of the outline of the aqueduct, points of control and location of the electronic descaling equipment

A1, A2, A3, B1, B2, B3, C, Z1 and Z2 are probing points.

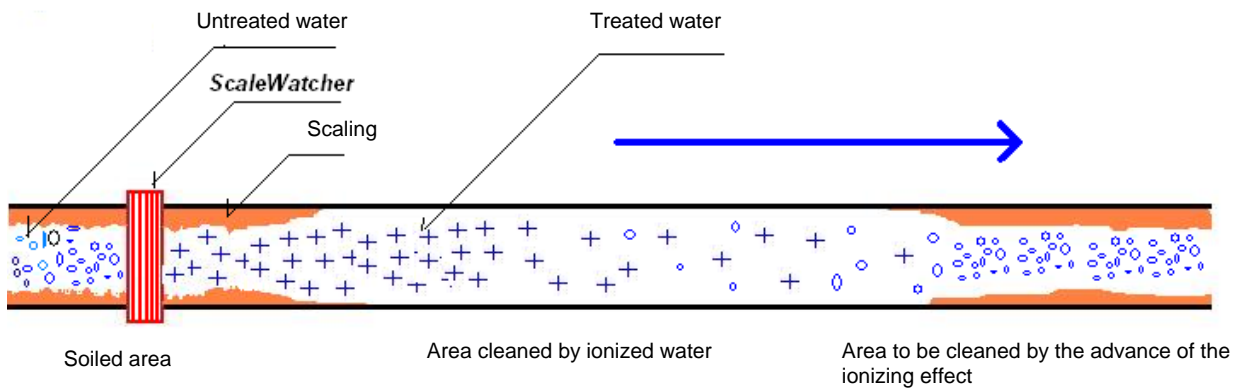
The graph shows the progress of the cleaning effect as the ionized water acts on the

accretions.

In the measure in which the tube is cleaned, the action of the ionized water moves forward until it dissolves the accretions located furthest away.
