## Scalewatcher®

## ECO-FRIENDLY SCALEWATCHER TACKLES SCALE IN SCHOOL BUILDING

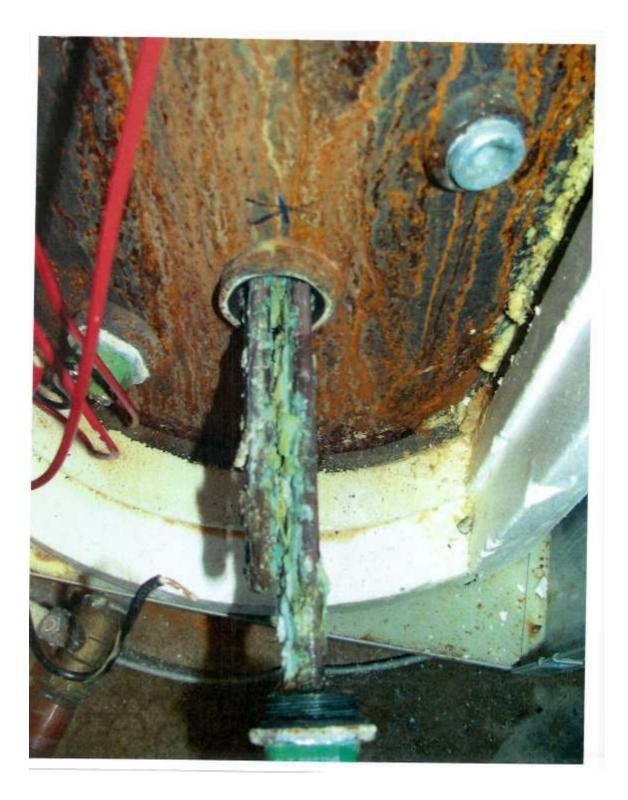
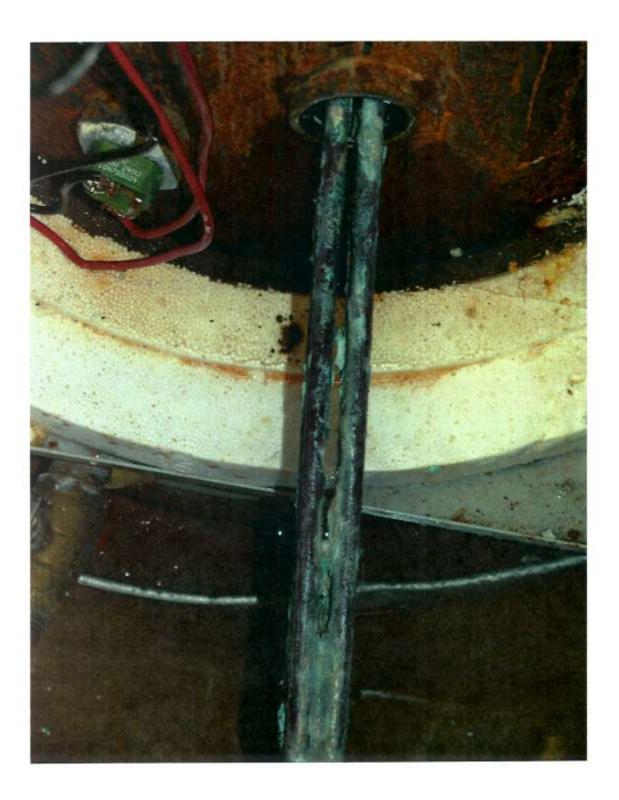
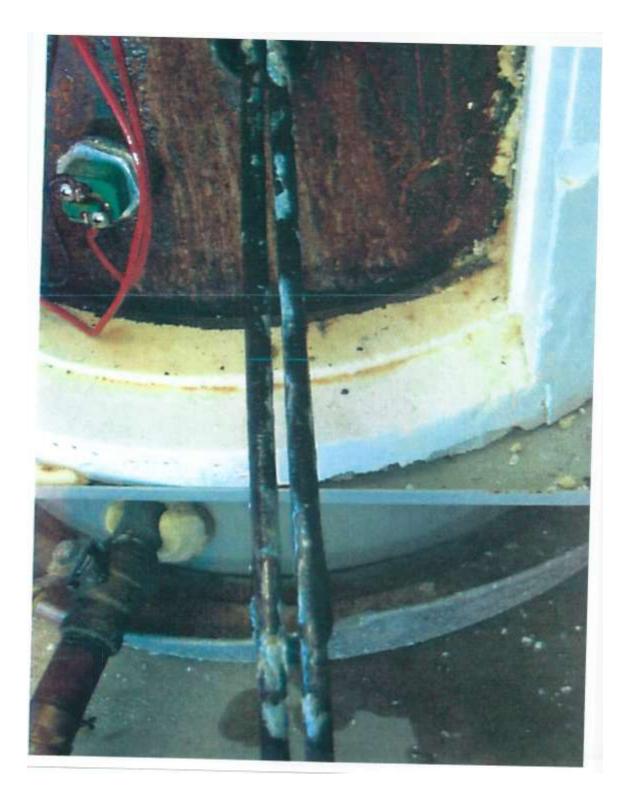
To monitor the scale removal, photographs were taken after the water was drained from the heater and the three heating elements removed. It was found that the scale build-up was so thick on the elements they had to be removed through a hole in the water heater. Installing the Scalewatcher took the two maintenance men only 20 minutes using a drill cement bit and a screwdriver. After three days the aerators had to be regularly cleaned as they were being blocked by scale breaking away from the water heater.

A week later, the same maintenance team drained the water heater again and removed the heating elements to find that 65% of the scale had dissolved. This was repeated again a week later whereupon it was found that 90% of the scale had gone. On each occasion photographs were taken of the water heater and elements to record the amount of scale removed. In addition the TDS was tested and found to have dropped to 1024ppm a reduction of 363ppm. Normally it would be expected that the TDS would rise whilst the scale was removed from the system. However on this occasion it is believed that the TDS dropped because not only had scale been removed from the pipework but also there was less corrosion.
