# Report of experiments on the prevention and removal of scale using "Scalewatcher<sup>™</sup>"

The end-user is Nippon Steel Chemical Co., Ltd. in Kitakyushu, Japan.

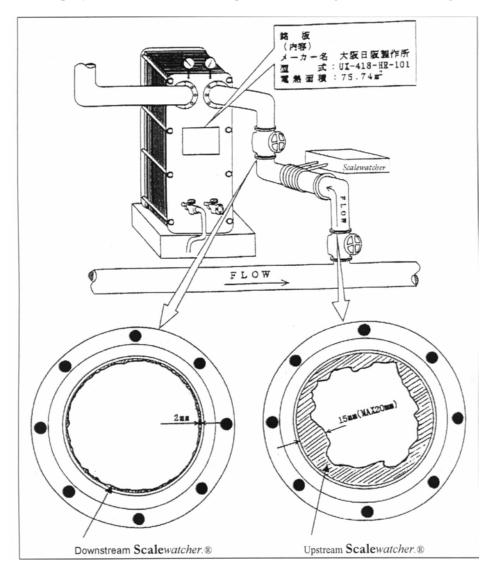
The company uses sea water to cool its plate heat exchanger. See the drawing.

After three months the pipe was taken down for inspection. The inlet flange just upstream of the **Scale** *watcher*<sup>®</sup> is shown to be still polluted (picture 2). Downstream of the **Scale** *watcher*<sup>®</sup> unit, the pollution has been significantly reduced. The scale build-up has been dramatically reduced from 15 mm (0.6") to just 2 mm (0.07") (picture 3). See also the drawing where A is downstream and B is upstream **Scale** *watcher*<sup> $\mathbb{T}$ </sup>.
