Newsflash 3, April 1997.
Section: Swimming Pools N° 1

Report of experiments on the prevention and
removal of scale using “Scalewatcher™”

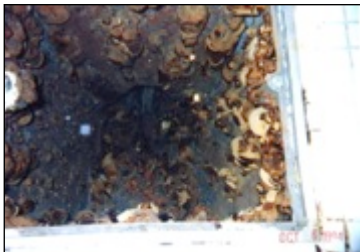
Scalewatcher also decreases the other problem, barnacles of iron bacteria. Pictures 3, 6 and 7 show how **Scalewatcher** is removing the barnacles at the outlet in the pool's deep end. These pictures have been taken from the Southern Deep Pool on respectively May 12, 1994, October 6, 1994 and September 9, 1995. The pictures show also a change in color of the barnacles from brown to black. This is a good sign according to Robert Finley.

6 Less barnacles. October 6, 1994

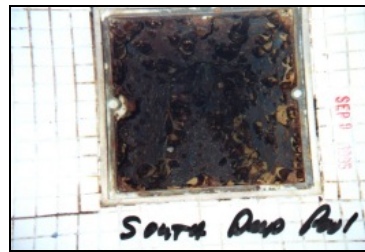
7 Barnacles shrunk and became black. September 9, 1995

The photographs that were taken during the trial showed that **Scalewatcher** had successfully begun cleaning the pipes, drains and outlets. The College was so impressed with **Scalewatcher**, that it immediately bought a unit. By using the **Scalewatcher** 2/3 of the total amount of muratic acid could be saved. The use of chlorine could also be reduced with 1/3. This will especially be welcomed by swimmers with sensitive skin and those who get sore eyes or have an allergic reaction to large quantities of chlorine in the water. It was also found that scum deposits (body yeast) disappeared from around the pool edge at the waterline and stainless steel fittings returned to their original condition. The pool water generally looked cleaner and fresher.
